**Estudo da qualidade da fundição do Titânio
comercialmente puro e da união soldada a laser em
estruturas de Ti cp e em liga de Ti-6Al-4V**

Dissertação apresentada à Faculdade de
Odontologia de Piracicaba da Universidade
Estadual de Campinas, para obtenção do
título de Mestre em Clínica Odontológica -
Área de concentração em Prótese Dental.

Título em Inglês: Analysis of titanium casting's situation and of laser-weld joints' quality made in Ti cp and Ti-6Al-4V structures

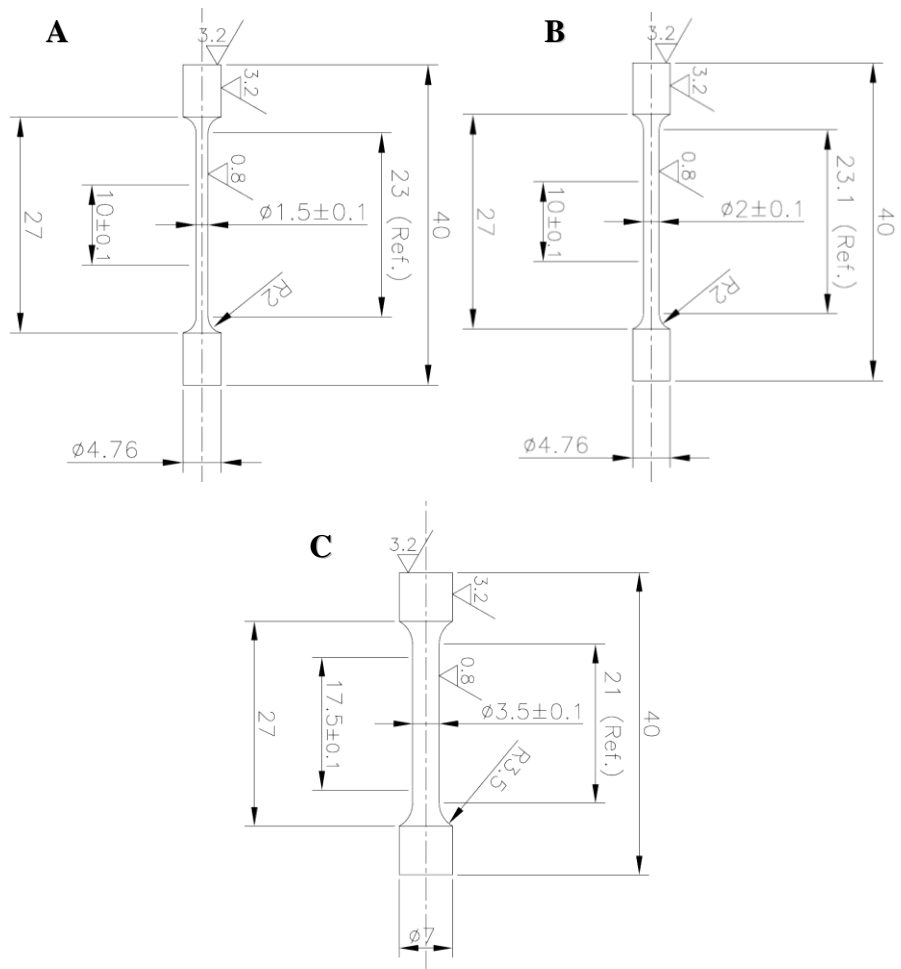
Figure 1: Specimen diameters (A) 1.5 mm (B) 2.0 mm (C) 3.5 mm.

Sixty dumbbell shaped rods (Fig. 1) with diameters of 1.5, 2.0 and 3.5 mm in the central segment were made in acrylic resin Duralay II (Reliance Dental Mfg Co, Chicago, USA) on a metal matrix, allowing the formation of three groups (n=20), G₁, G₂ and G₃, respectively. The dumbbell rod dimensions were based on ASTM E8M-04¹⁴. The diameters used simulated the following situations: G₁, three element fixed prosthesis frameworks; G₂, overdenture bars; G₃, ten element fixed prosthesis frameworks. The acrylic resin dumbbell rods were visually observed, to evaluate any flaw in the structures and casted in a vacuum injection titanium casting machine (Rematitan System; Dentaaurum, Pforzheim, Germany) with commercially pure titanium (CP Ti)⁴. To accomplish this, acrylic resin patterns of each specimen were invested (Rematitan Plus; Dentaaurum, Pforzheim, Germany) using a 250g powder and 40 mL liquid ratio and mixed under vacuum, according to the manufacturer's instructions. After setting, invested specimens were heated using a slow heat cycle¹⁵ for wax removal. Following identical manufacturing

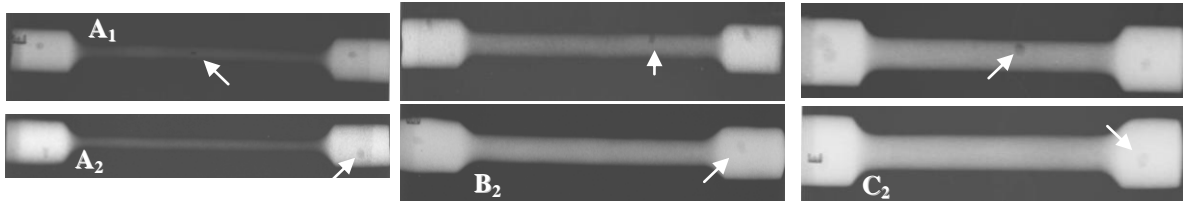
Figure 2. Specimen radiographies:

Internal porosity (A₁ / A₂) 1.5mm (B₁ / B₂) 2.0mm (C₁ / C₂) 3.5mm

The radiographic examination, mentioned in the literature, ^{9, 10} is an efficient evaluation procedure, allowing the visualization of internal porosity in specimens casted in CP Ti (Fig. 2). Table I shows the incidence of internal porosity (%) found in the central sections of the dumbbell rods of all diameters. Regardless of the central diameter, the

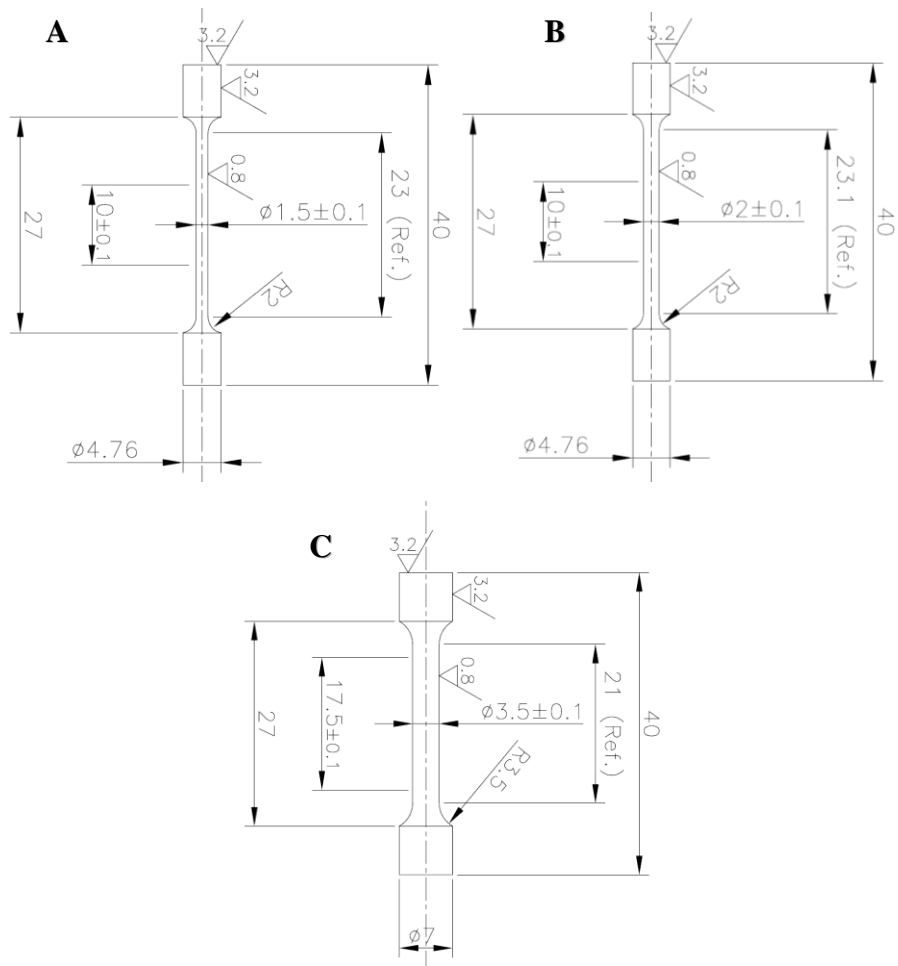
Figure 1: Test specimen (A) Diameter of 1.5 mm (B) Diameter of 2.0 mm (C) Diameter of 3.5 mm.

The diameters and opening joints were selected to simulate the following situations: 1) Central diameter of 1.5 mm: three element fixed prosthesis frameworks; 2) Central diameter of 2.0 mm: overdenture bars; 3) Central diameter of 3.5 mm: ten element fixed prosthesis frameworks; 4.) 0.0 mm joint opening: precast cut; 5.) 0.6 mm: cut with thin disc.

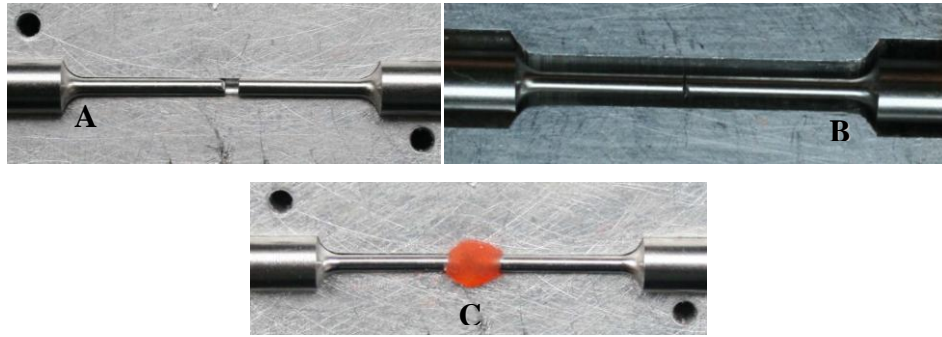
Figure 2: Test specimens: **A.** Joint opening of 0.6 mm / **B.** Joint opening of 0.0 mm / **C.** Joint with acrylic resin.

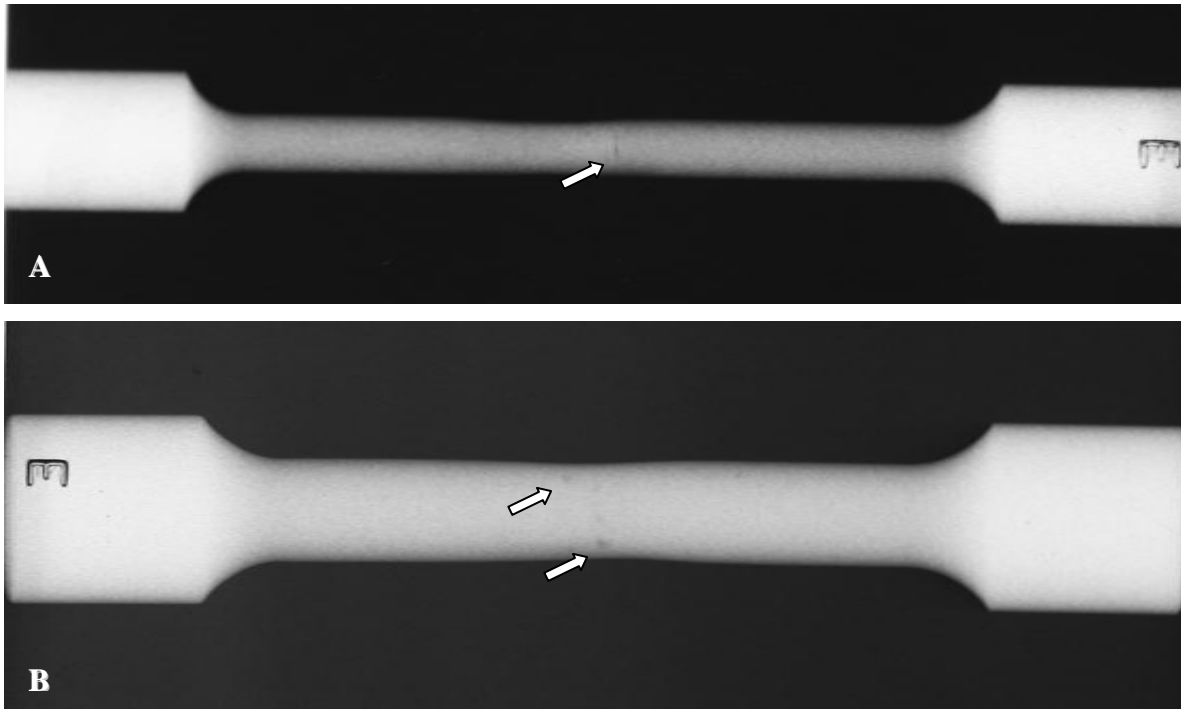
Figure 3: Radiographic evidence of the presence of porosity (arrows), in 2.0 mm, 0.0 mm distance (**A**) and 3.5 mm, 0.6 mm distance (**B**) test specimens.

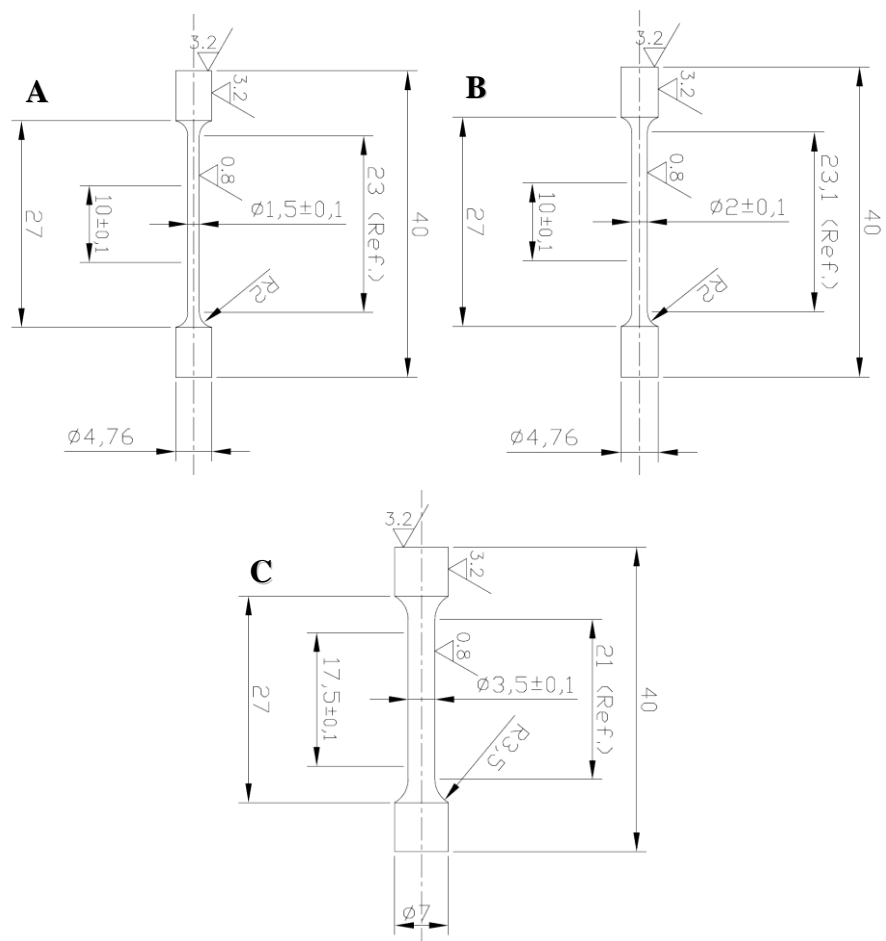
Figura 1: Corpo de prova de (A) 1,5 mm de diâmetro (B) 2,0 mm de diâmetro (C) 3,5 mm de diâmetro.

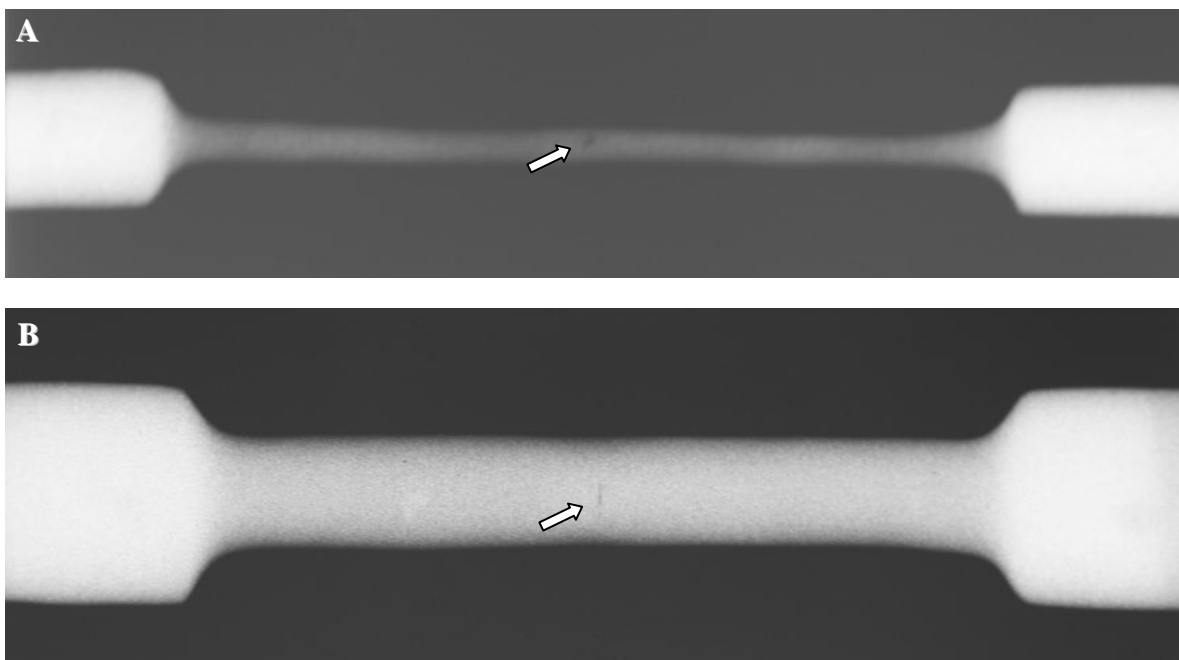
Figura 2.: Radiografias evidenciando a presença de porosidade, nas uniões: **(A)** diâmetro de 1,5 mm e distância 0,6 mm; **(B)** Diâmetro de 3,5 mm e distância 0,0mm.

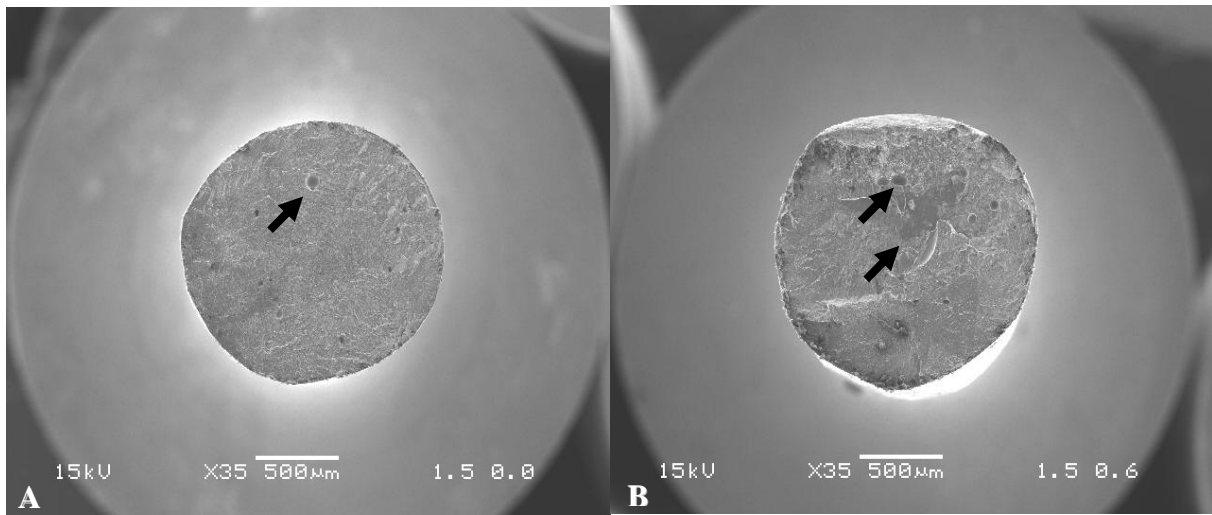
Fig. 1: SEM photomicrograph of fracture surface in 1.5 mm-diameter specimens: **A.** 0.0 mm joint opening / **B:** 0.6 mm joint opening.

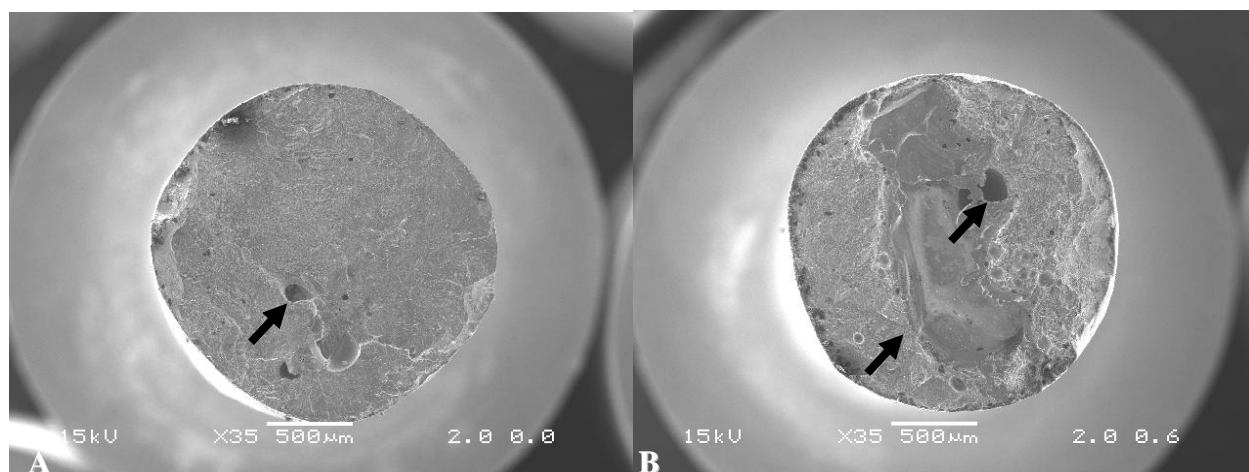
Fig. 2: SEM photomicrograph of fracture surface in 2.0 mm-diameter specimens: **A.** 0.0 mm joint opening / **B:** 0.6 mm joint opening.

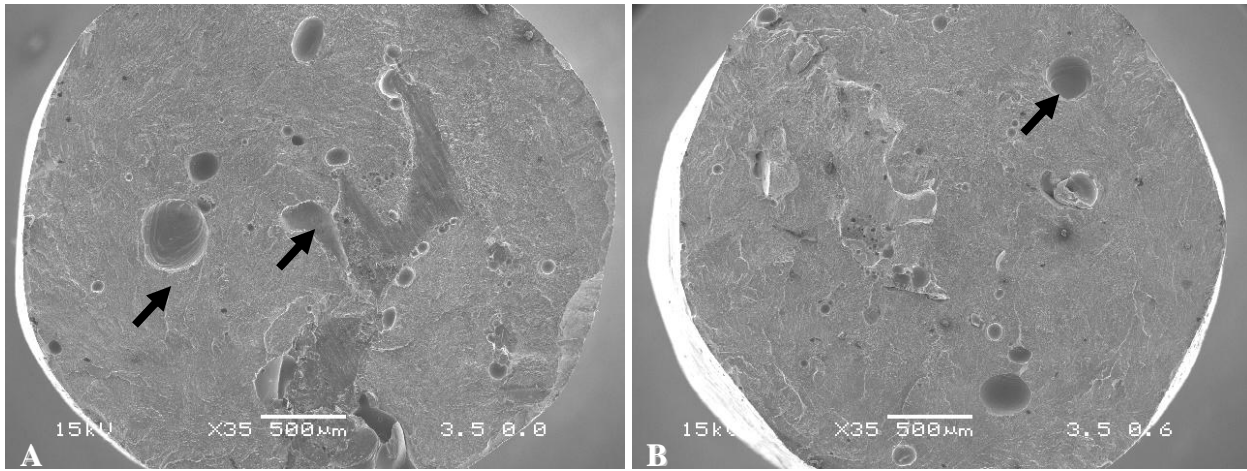
Fig. 3: SEM photomicrograph of fracture surface in 3.5 mm-diameter specimens: **A.** 0.0 mm joint opening / **B:** 0.6 mm joint opening.

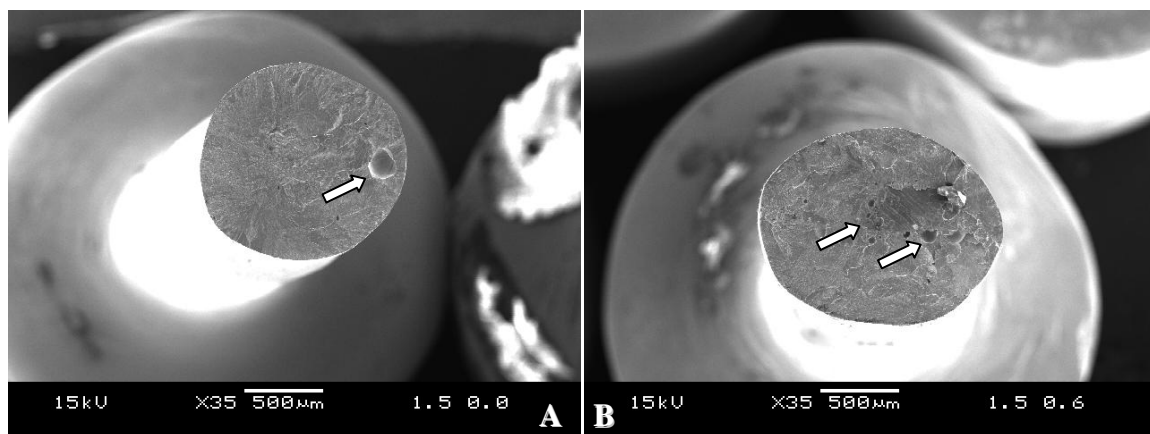
Fig. 1: SEM photomicrograph of fracture surface in 1.5 mm-diameter specimens: **A.** 0.0 mm joint opening / **B:** 0.6 mm joint opening.

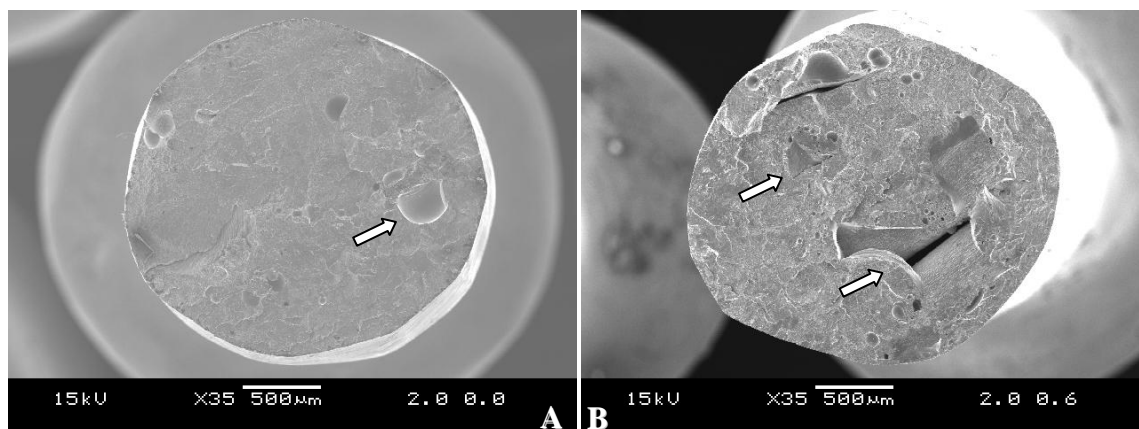
Fig. 2: SEM photomicrograph of fracture surface in 2.0 mm-diameter specimens: **A.** 0.0 mm joint opening / **B:** 0.6 mm joint opening.

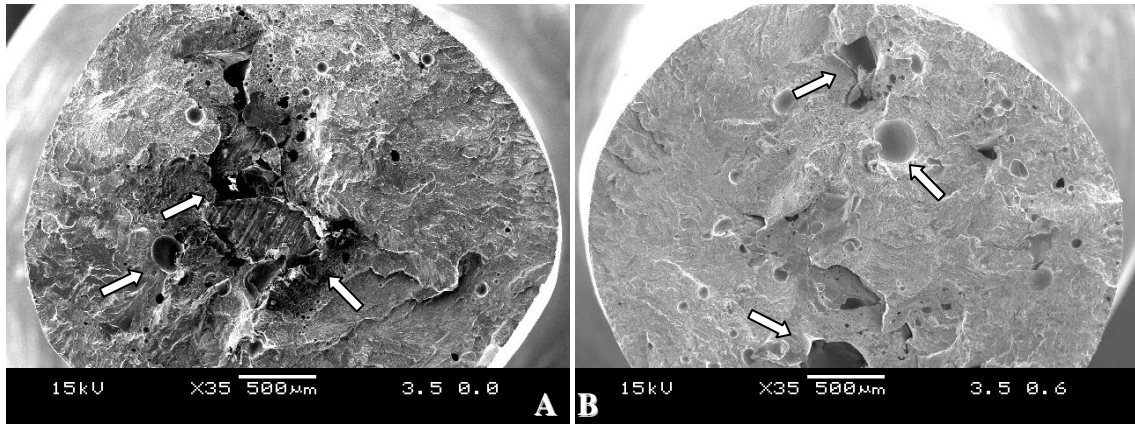
Fig. 3: SEM photomicrograph of fracture surface in 3.5 mm-diameter specimens: **A.** 0.0 mm joint opening / **B:** 0.6 mm joint opening.

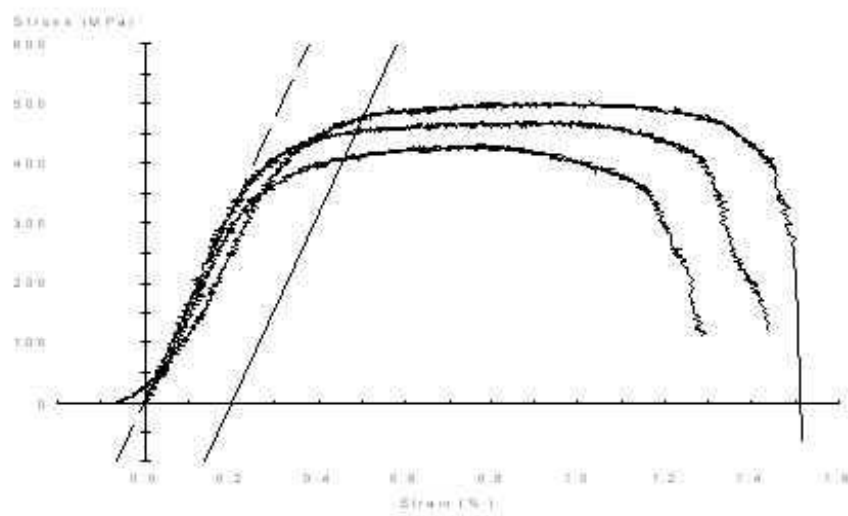
Gráfico 1. Curvas Tensão x Deformação para os 3 corpos de prova fundidos extras tracionados.

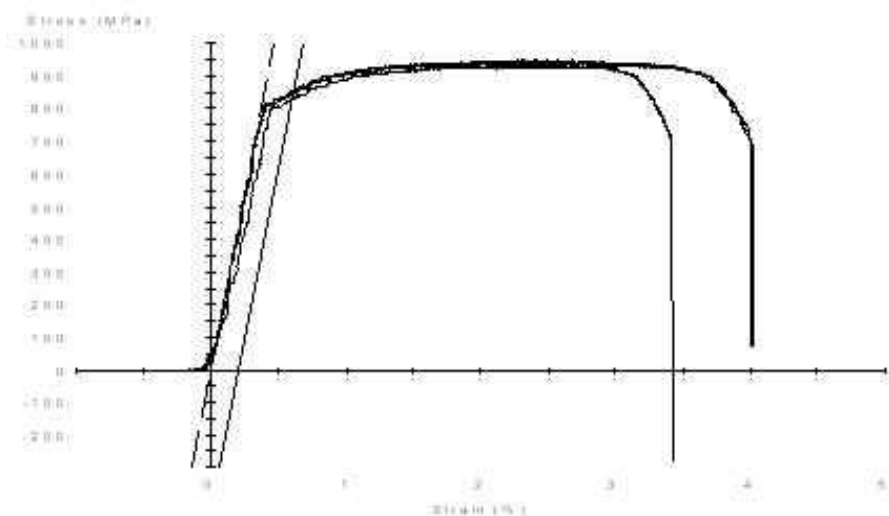
Gráfico 2. Curvas Tensão x Deformação para os 3 corpos de prova usinados extras tracionados.
